Service Bulletin

Bulletin No.: P11010

Subject: Round Dark Stains on Roof Paint Center Rear Area

Models: 2010-2014 Chevrolet Equinox
2010-2014 GMC Terrain
All without RPO CF5 Sunroof

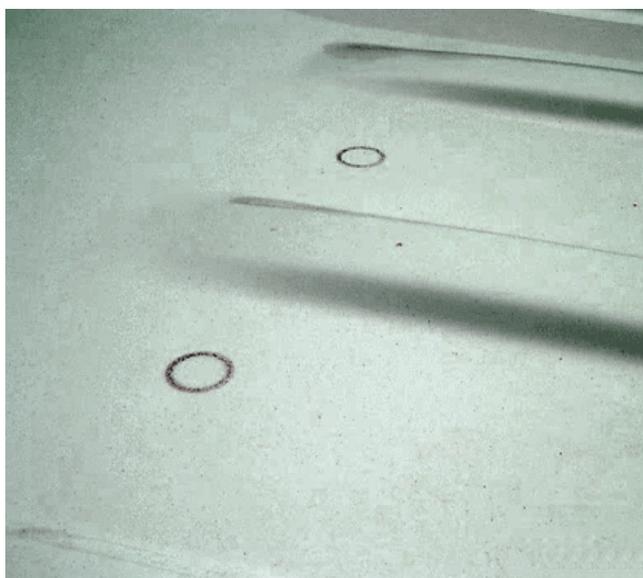
3471163

Some customers may comment that two dark circles of paint discoloration have formed in the center of the exterior roof panel. This condition is most noticeable on light colored vehicles.

This condition may be caused by the headliner retention magnets attracting steel or iron dust. This dust, combined with moisture, causes a dark/rust colored stain that does not wash off during routine vehicle washing.

Use the following steps to remove the stain and install two metal plates (latch striker spacers) inside of the roof. These metal plates will isolate the magnetic attraction from the exterior of the outer roof panel.
